# ARTIFACT ANALYSIS

**Artifact Name/Title:** Faded street pavement markings

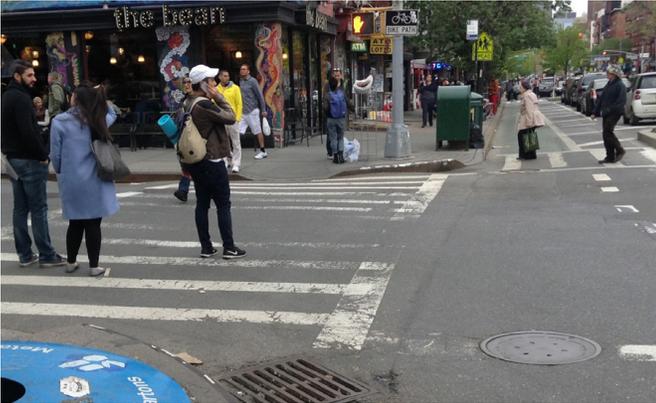
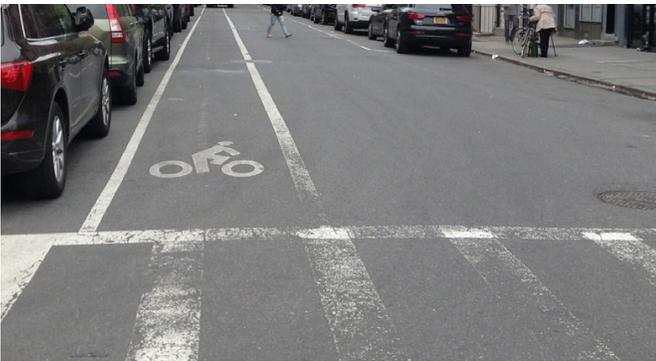
There are pavement markings denoting a crosswalk and bike lane. Parts of these markings are fading away much more than the rest of them.

Where is it from? Markings were likely worn away by motor vehicles.

Cars turn this way most of the time and the bike lane is frequently run over by them. Motor vehicle angle for turning is relatively wide (and fast) as revealed by the desire lines. A turn made at closer to 90 degrees would be slower and have better visibility of the people crossing and biking by.

Restrict motor vehicle turning speed and extend physically protected bike and pedestrian space to make it safer and because the desire lines reveal that motor vehicles don't require all the space allocated to them to make the turn.
